TSB00-0401

## TECHNICAL SERVICE BULLETIN

Fire Trucks with DDEC (Detroit Diesel) Engine AND Involved in Recall Campaign #RSB 99V-010 or #RSB 99V-010A.

**RECALL SERVICE BULLETIN****SUBJECT:****Cab Tilt Solenoid Failure****APPLIES TO:**

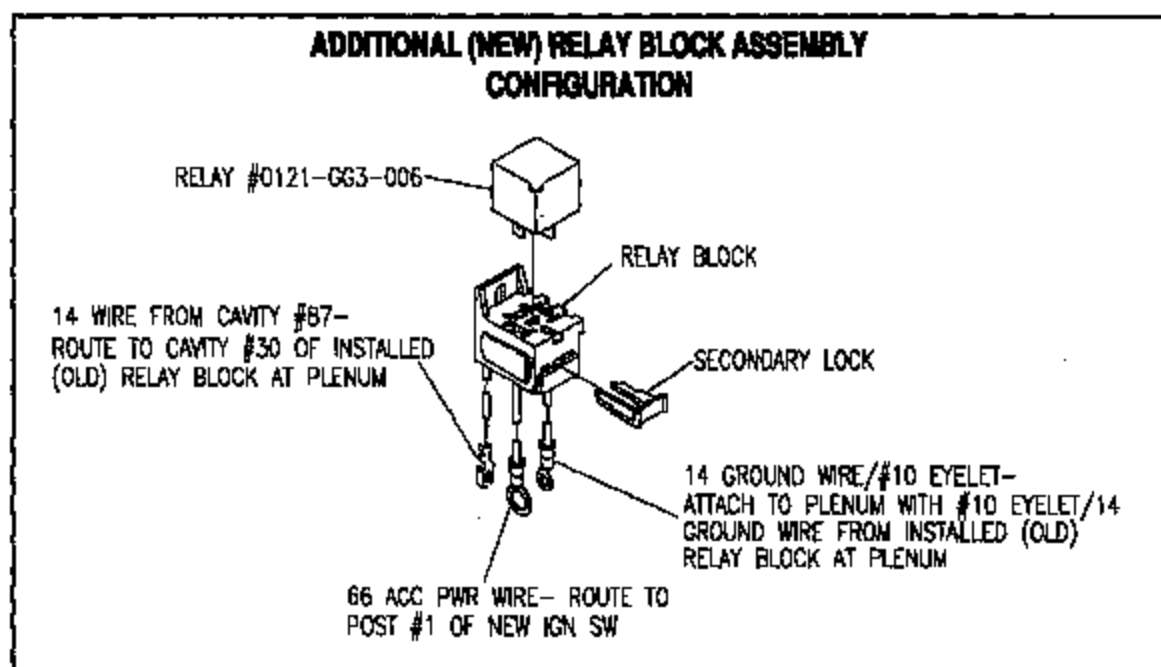
**FIG. 4-1**

'Engine' and 'Check Engine' Warning Lights Illuminate When Battery Master Switch is Turned On and Then Turned Off; May also experience 'Engine Run-On'.

Voltage Signal Present at the Engine ECU Causing Activation of the ECU "Wake-Up" Signal.

- 16c. Ensure the park brake is set, cab is empty of all occupants, and the master and ignition switches are in the "ON" positions. Initiate the cab tilt function to raise the cab. The cab should NOT raise, but can be lowered.
- 16d. Ensure wheels are chocked. Repeat steps 16a-16c with the park brake released. The cab tilt system should NOT function under any of these conditions.
17. If all tests are successful, no further action is required. If any of the tests fail, review the procedures in the document #RSB99V-010 or #RSB99V-010A to verify the cab tilt repair procedure has been completed properly, and review the procedures in this bulletin for accurate application. Contact Spartan Motors Customer Assistance Center if any assistance is needed, 1-800-543-5008.
